TRIMMING DIE'S ADJUSTMENT

Arnold Szakacs ¹

¹University Of Oradea, szakacsarnold@yahoo.com

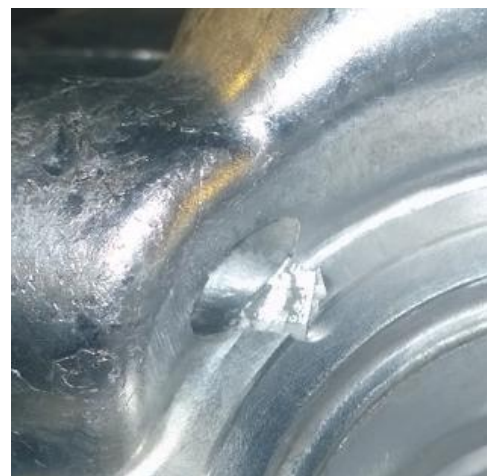
Figure 1. Missing material.

But, if we have some problems with the Trimming Die, we find the root cause of the problems very quickly because he shows on the parts if there is some problems with the Trimming Die (friction, missing of material etc), figure 1,2.

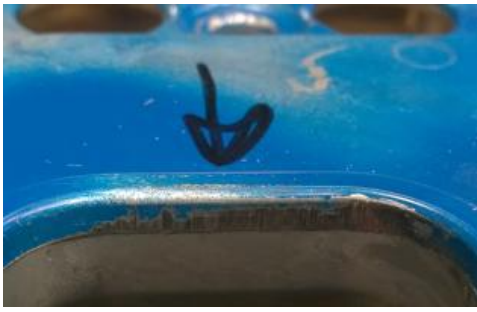
Figure 2. Friction.

If the castshot is very hot when will be cutted, on the internal side of the cutter, remain soldered material, which leaves friction on the surface of the trimmed parts.

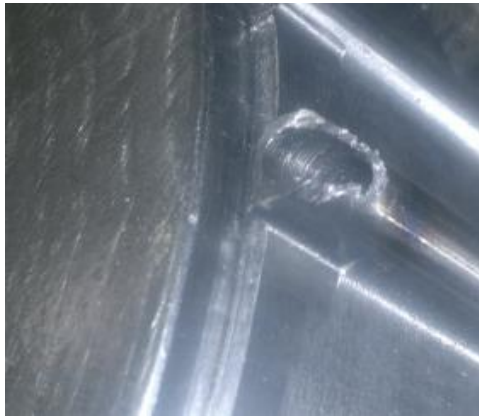
Figure 4. Support breakage.

The support under the cast shot and under the ingate must be flatt and in contact with him. If he does not contact it with the ingate, figure 4,5,7, when the cutter come down and cut down the ingate, the ingate there is nothing under it that let him keep it, the cutter will not cut down it but it will break down and we have missing of material on the ingate zone.

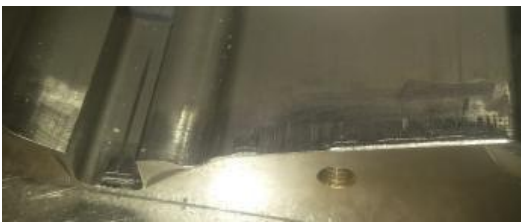
Figure 5. Support worn out.

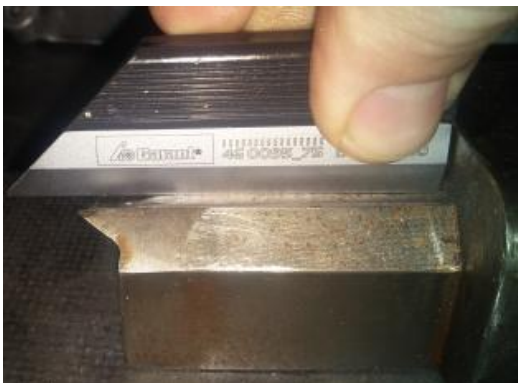
Figure 6. Missing material (cutter).

- -temperature of the cast shot
- -thickness of the ingate
- -primary and secondary angle of the cutter and pin, figure 6,8,9,10

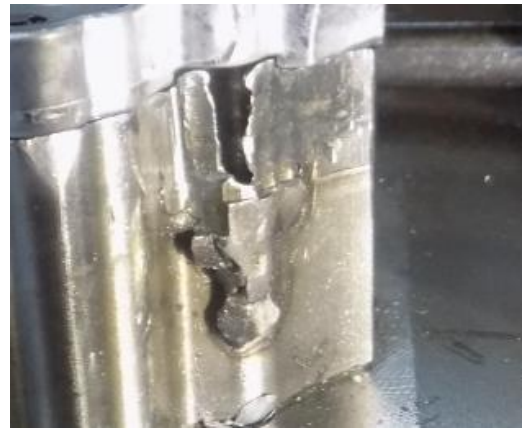
Figure 7. Support breakage.

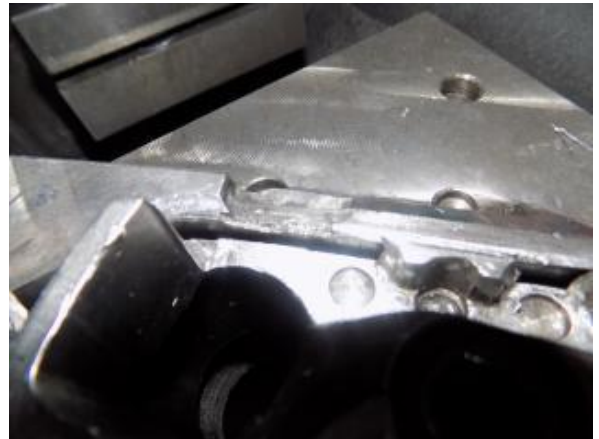
Figure 8. Worn out (lower cutter).

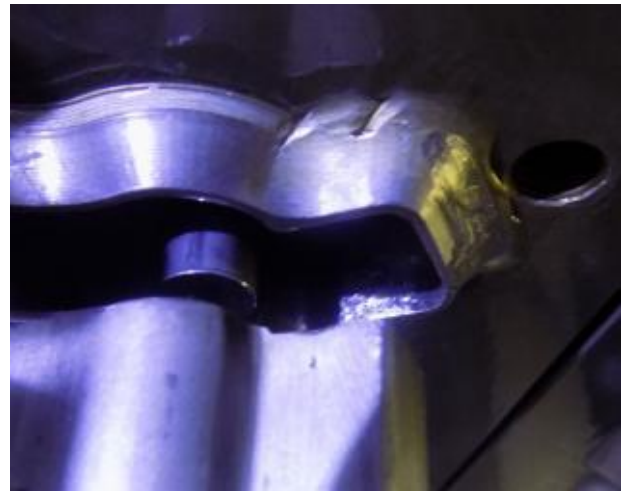
Figure 9. Worn out (upper cutter).

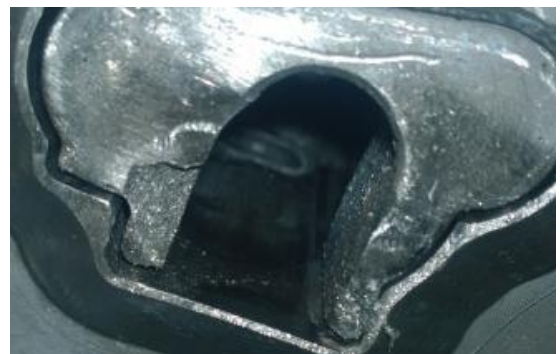
Figure 10. Worn out (cutter).

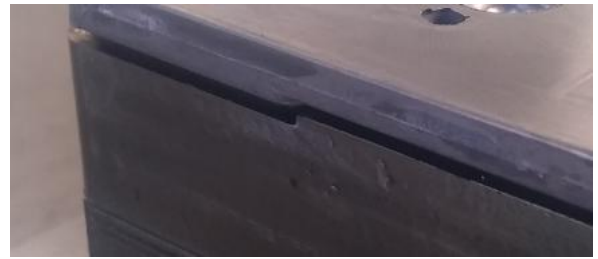
Figure 12. Distance between the support and part, caused by temperature.

If the trimming die is designed for the parts which has a temperature 50° (for example) , when we cut down the ingate and the burrs from the parts who has a temperature 100°-150°,we will get into the geometry of the parts, or we can not even sit down the castshot on the support, figure 12.

For example to aluminium, at 100° we have a difference 1,5mm.

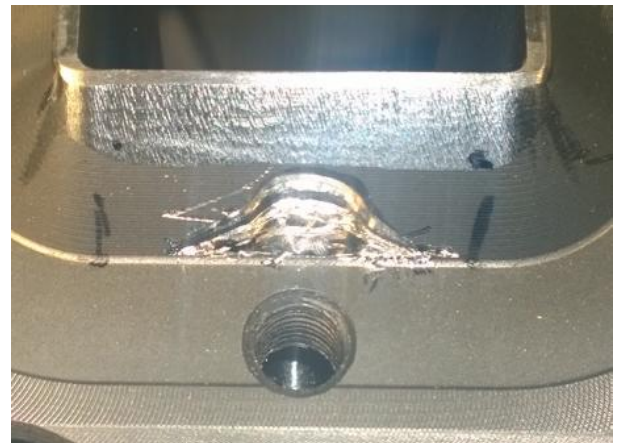
Figure 13. Milling (cutter).

If anything happens with the trimming die, in the first step are necessary to checked the root cause of the problems. At the first, we try to adjust the trimming die without redesign. If he is needed, let us recharge it then or we are milling/ rectifying, figure 13,14.

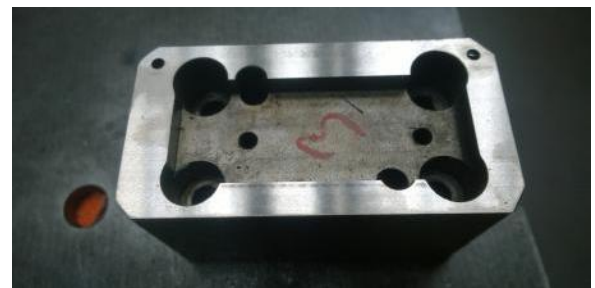
Figure 14. Rectification (support).

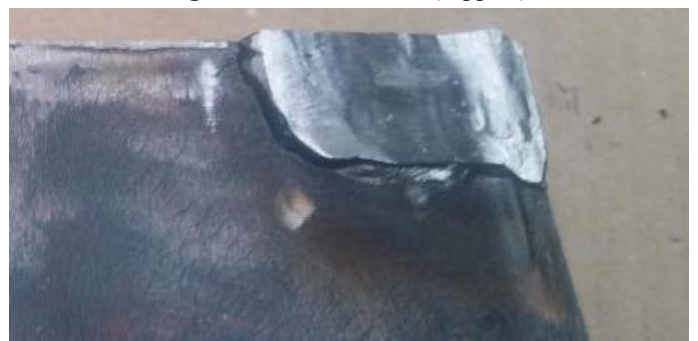
Figure 15. Welding with TIG

If is not possible to solve the problems by welding, figure 15, [2] milling or with any technological process to save components of the Trimming Die, it is necessary to modify the Trimming components (cutters, support, pins), figure 11.

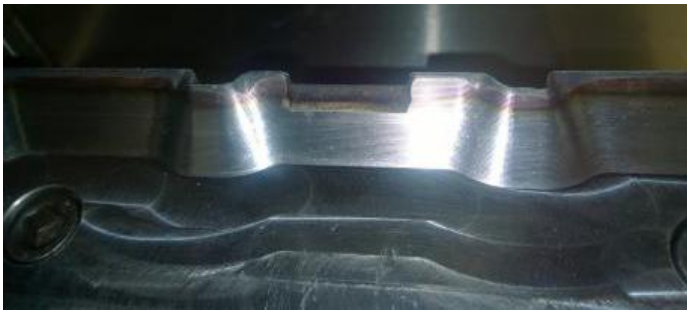
Figure 16. Heat treatment (cutter)

When we finished the modification on the trimming die, it is necessary to use heat treatment on the active zones (completely or partially).

After the adjusting it is necessary to use local heat treatment for to have more resistivity, figure 16.

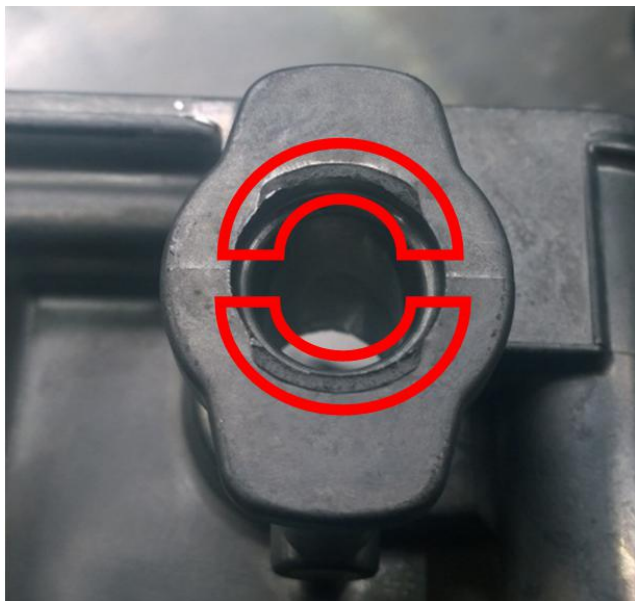
Figure 17. Overflow breakage .

For this problem (missing material) it is necessary to redesign the Trimming Die, figure 17. The Trimming Die manufacturers, in the design phase, used the CAD/CAE /CAM softwares [7][8] can be eliminate the eventually problems, but only in the tool try out phase can be noticed the really problems with the trimming die, because it's not sure that in the 3D model how to behave the cast shot.
